This Upland Site Summary was authored by Texaco, Inc. The opinions, statements and conclusions herein are solely those of Texaco, Inc. They are not adopted by and should not be attributed to any other person.

FORMER PARAGON OIL TERMINAL

Address: 16, 42, 50 Bridgewater Street, Brooklyn, New York 11222
Tax Lot Parcel(s): Brooklyn Block 2666, Lot 1; Block 2666, Lot 52; Block

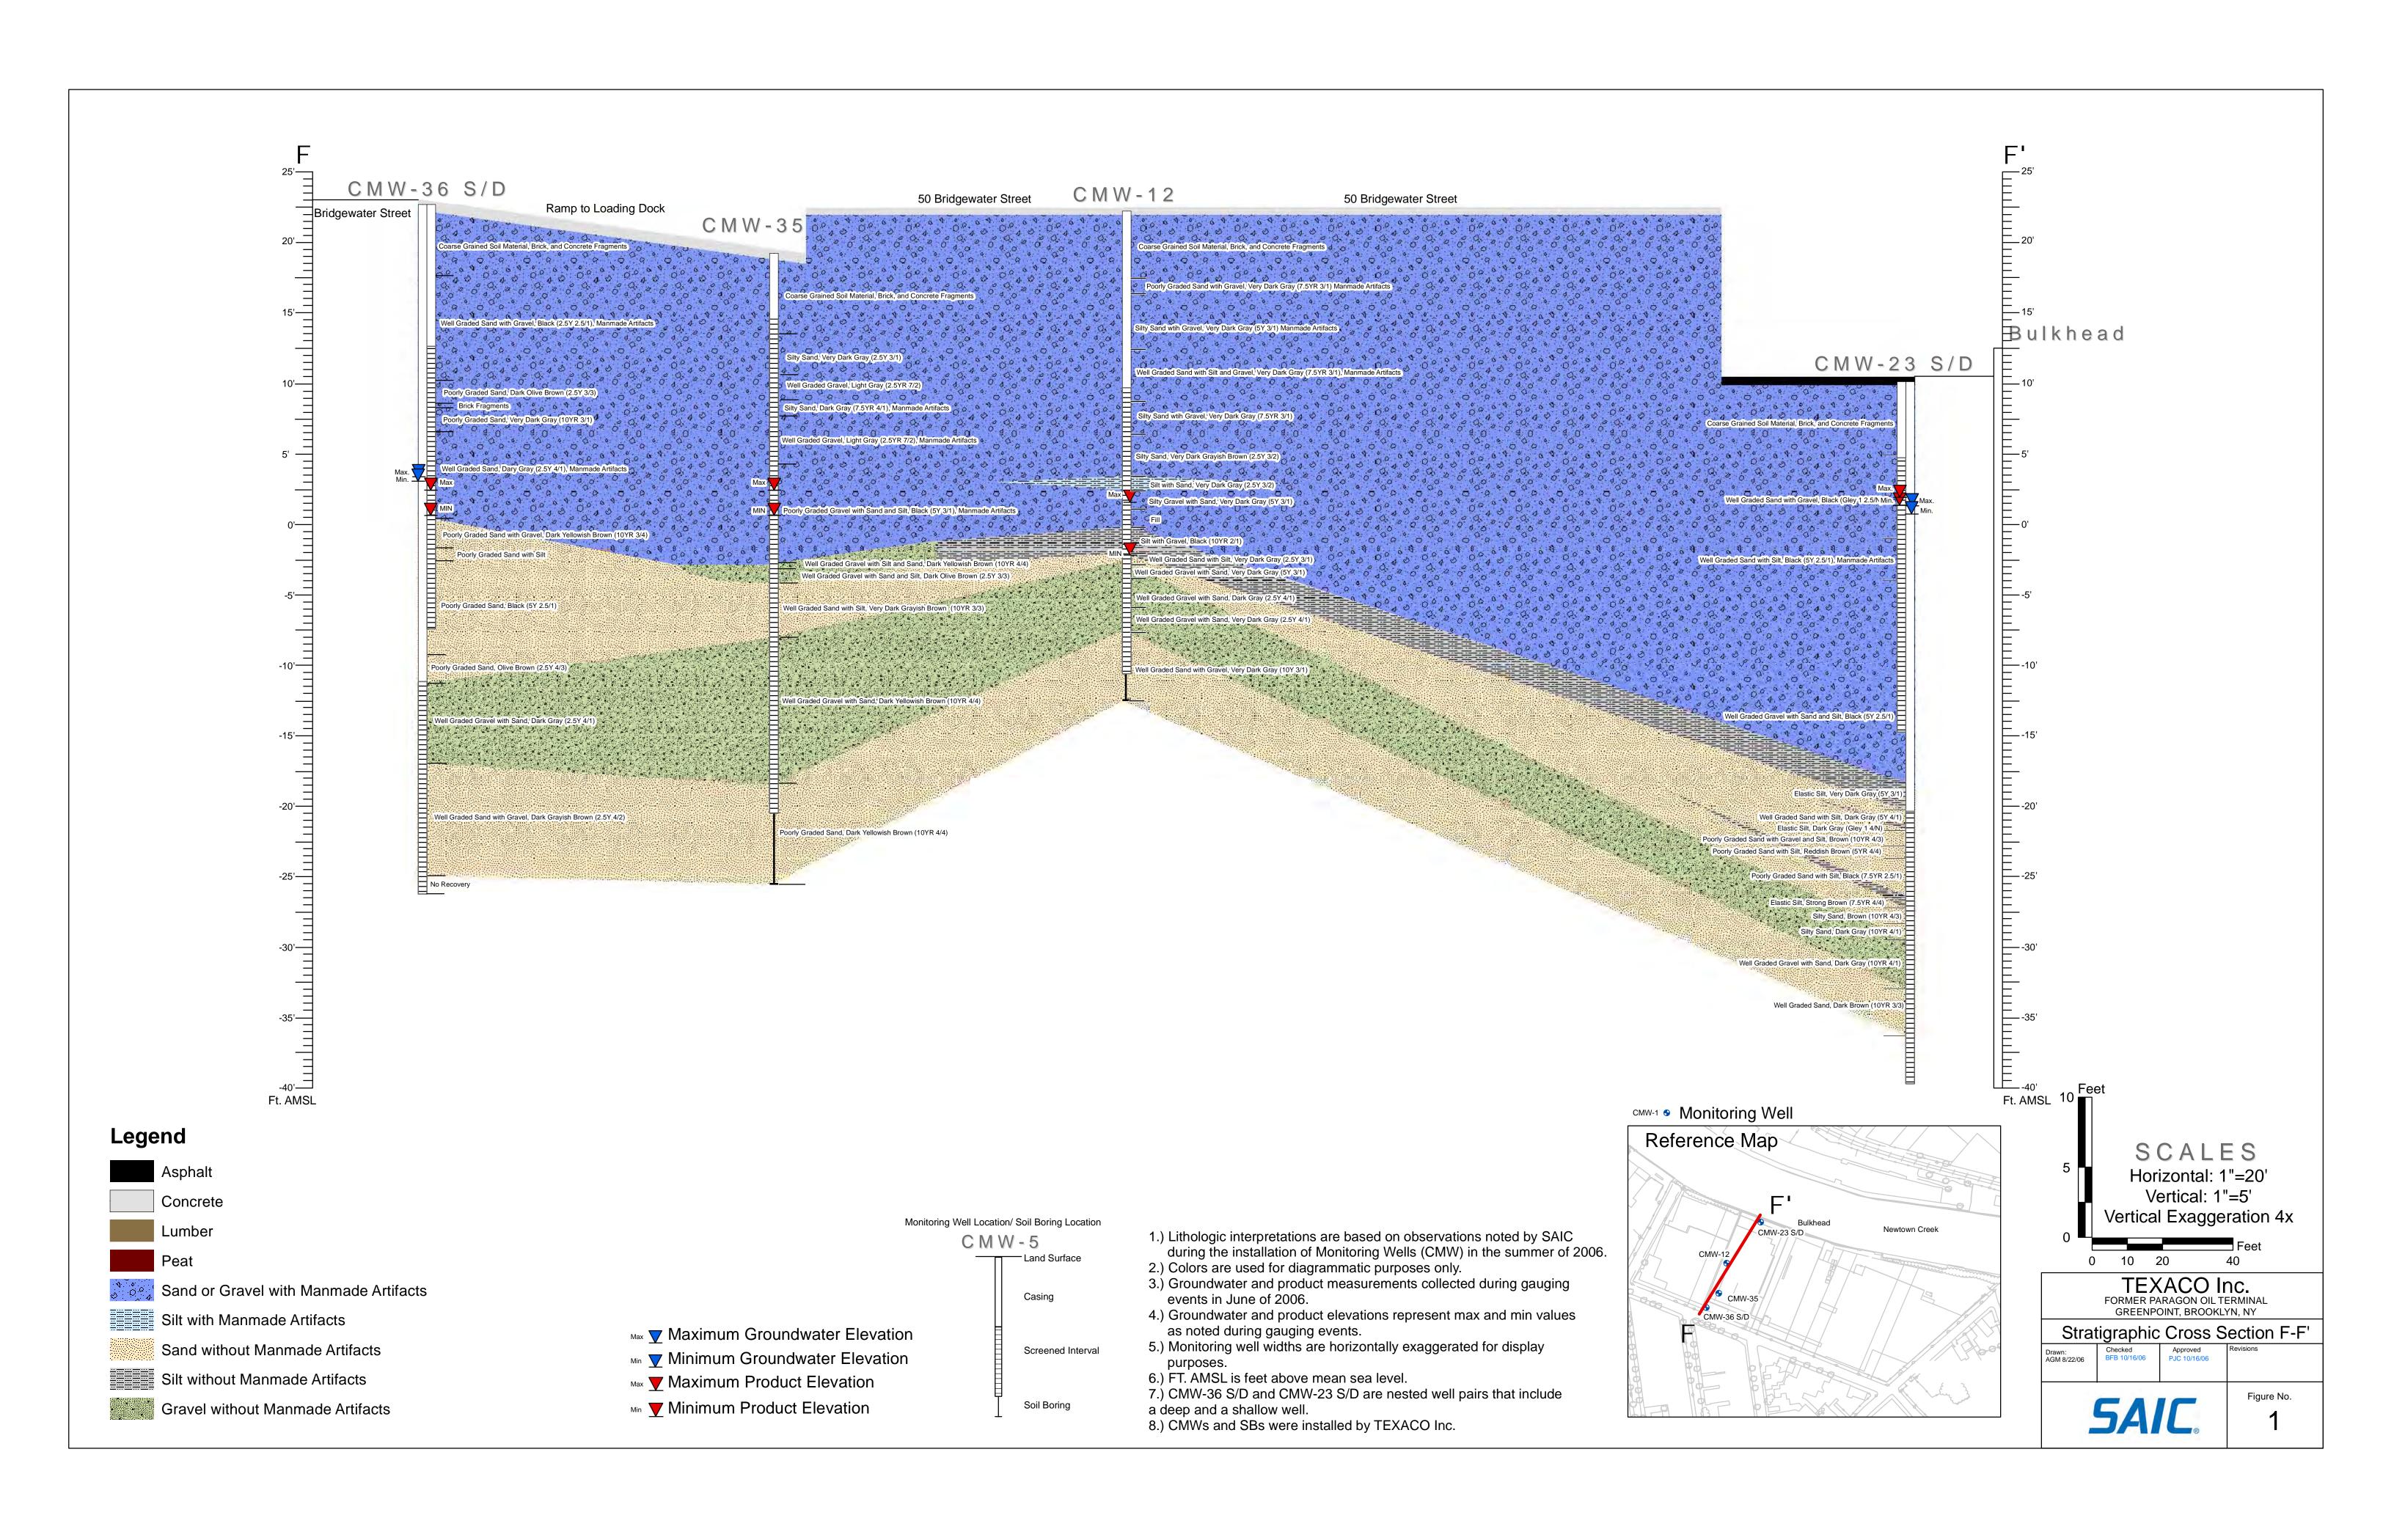
Figure 1 presents a stratigraphic cross section perpendicular to the creek while Figure 2 presents a stratigraphic cross section parallel to the creek.

The site is underlain by a unit of fill material that was put in place prior to 1900 based on available information. The fill is comprised of coarse-textured sand and gravel with man-made artifacts such as bricks, nails, glass, and other man-made materials. There exists a naturally occurring alluvial silt layer under the fill zone that extends from Newtown Creek southward toward Bridgewater Street. On the western part of the site the silt layer does not extend to Bridgewater Street. This alluvial silt zone was the base of Newtown Creek prior to 1886. Both the free water table and the upper surface of the LNAPL zone are present within the fill zone and above the alluvial silt layer. Underlying the alluvial silt layer at two locations are naturally occurring peat zones, and at greater depth, the native alluvial sand and gravel zone is present. On the Bridgewater Street side of the site, the alluvial sand and gravel is directly beneath the fill.

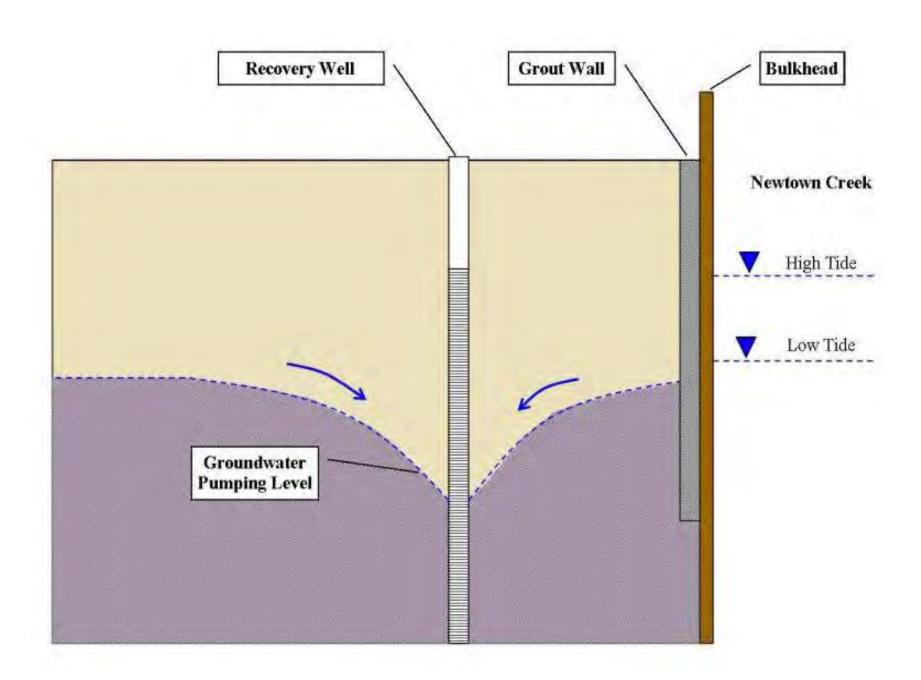
Figure 3
Reversed Hydraulic Gradient Concept Maintained to Mitigate Seep

As previously stated, the water table and the LNAPL are present underneath the site within the upper fill zone Figure 3 presents a concept diagram of the reversed hydraulic gradient that is created and maintained by the total fluids recovery system that is operating behind the bulkhead. Figure 4 presents an actual low tide data set indicating the pumping groundwater elevations behind the bulkhead are all below the elevation of the creek surface water elevation. The maintenance of this reversed hydraulic gradient has been effective in mitigating the seep. Figure 5 presents the LNAPL and groundwater capture zone induced by each of the recovery wells behind the bulkhead at low tide. The reversed inward gradient created by the pumping behind the bulkhead ensures that both groundwater and PSH do not seep into Newtown Creek.

The recovery system currently maintains a reversed hydraulic gradient during both high and low tide on the creek. The inward gradient is achieved by maintaining a groundwater elevation that is below the creek surface water elevation at both low and high tides. In 2011 NYSDEC gave Texaco approval to remove the outer containment boom system.

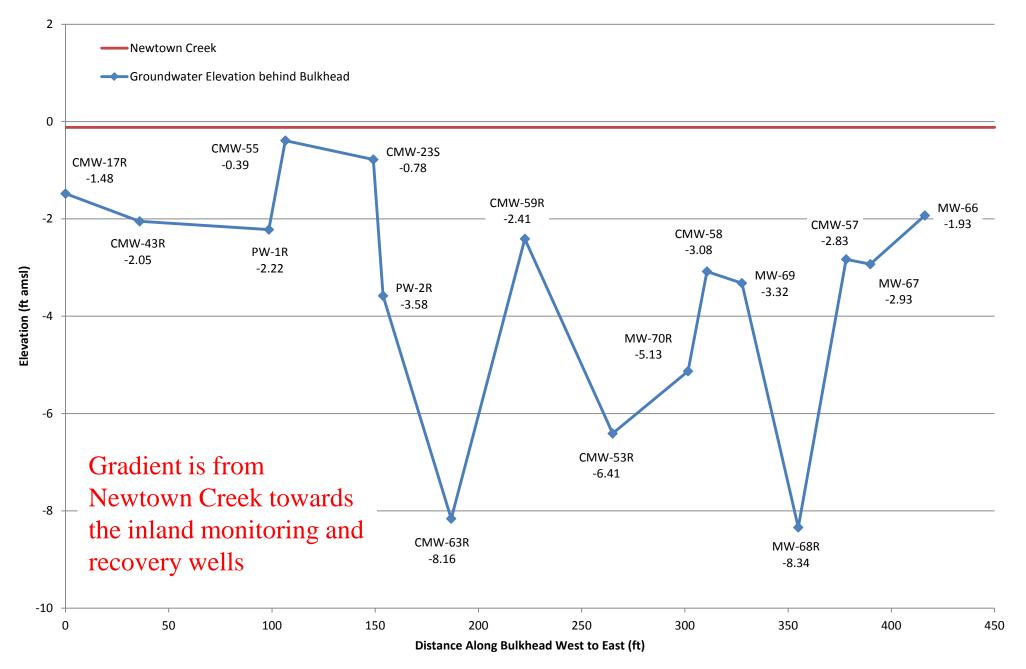
Figure 4
Comparison of Surface Water Elevation in Newtown Creek with
Groundwater Directly Behind the Bulkhead Along the Former Seep Area

Comparison taken at Low Tide on September 21, 2010 (14:35)

The natural groundwater flow is, generally, from south to north across the property towards Newtown Creek. Since Newtown Creek is a tidal water body, the local groundwater immediately behind the bulkhead experiences tidal fluctuations. The current remedial system maintains hydraulic control under both high and low tidal conditions, with a continuous inward gradient from the Creek onto the site. However prior to the current remedial action, groundwater did discharge to the creek during low tide cycles. Therefore groundwater was a complete pathway during time when the seep began in 1991 until mitigation of the seep with the operation of the total fluids recovery system by the end of 2010. The hydraulic control provided by Texaco's system is also having the beneficial effect of addressing offsite sources of contamination that have migrated on to the Texaco site and are attributable to others." Groundwater is not a current pathway.

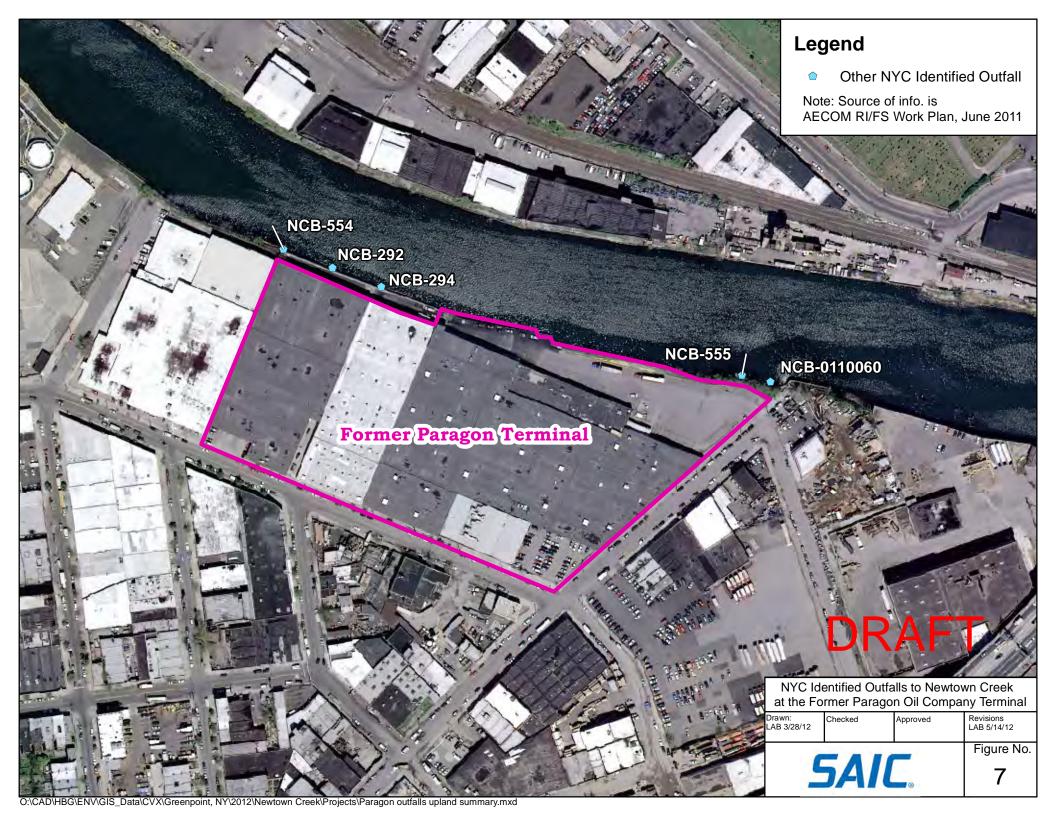
Five New York City outfalls along the site bulkhead were identified in AECOM's RI/FS Work plan dated June 2011. These outfalls are not associated with the Former Paragon Oil Terminal. These outfalls are shown on Figure 7, and described in Table 6 below.

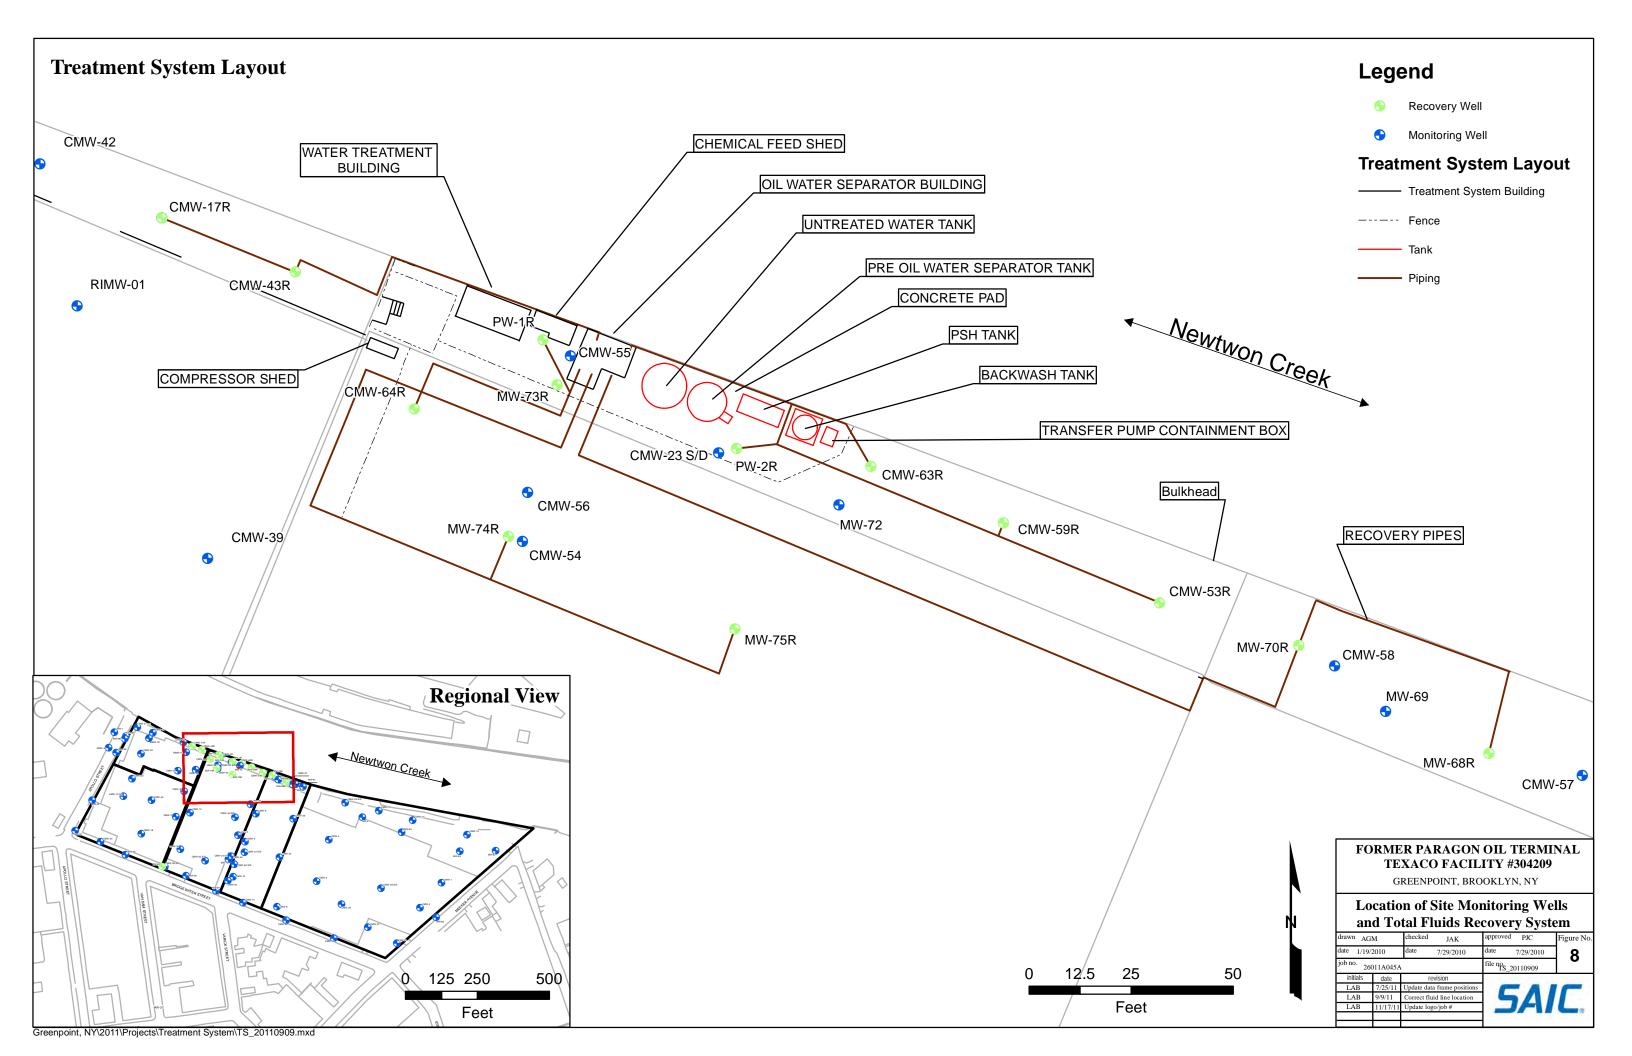
A TFR system recovers groundwater and LNAPL from a system of 11 recovery wells located immediately behind the grout wall on the Paragon site (Figure 8). The removal of LNAPL and impacted groundwater in order to maintain a reversed groundwater gradient away from the creek, has contributed to mitigating the seep.
